# Home Inspection Report

of  
Address

**INSPECTIONS**™

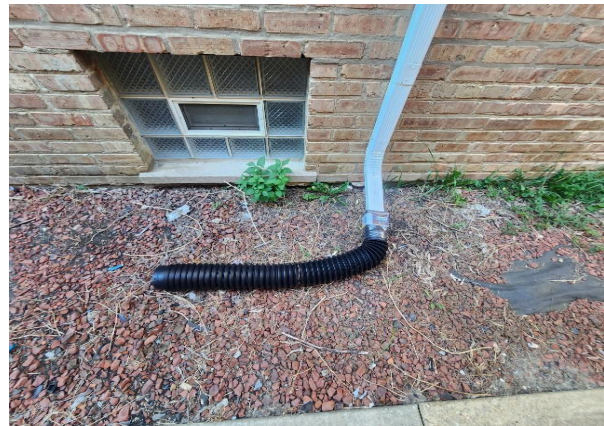
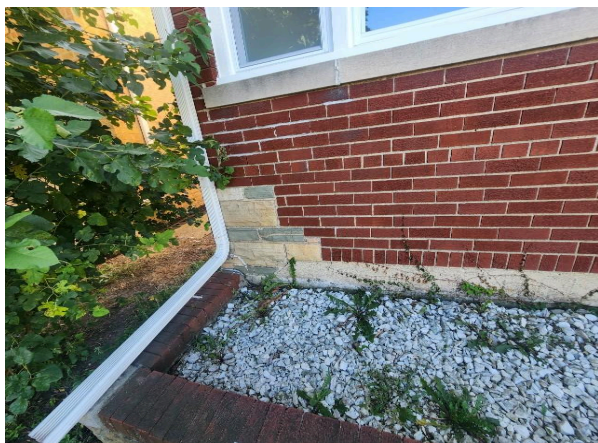
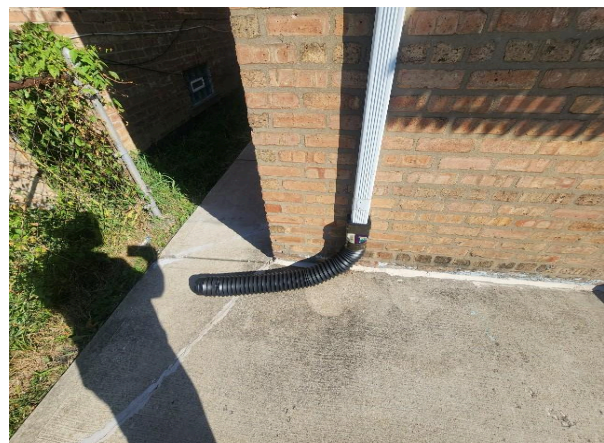
- A. Several downspout extensions terminate too close to the foundation. This condition may allow water to pool near the structure, increasing the risk of moisture intrusion or foundation damage.
- B. The garage concrete floor is uneven. As a result, the overhead door does not sit flush when closed, leaving a gap on the east side that may allow moisture, pests, or air infiltration. Recommend evaluation and correction by a qualified contractor to improve function and sealing.
- C. The overhead garage door failed to operate when the control button was activated, indicating a possible mechanical or electrical issue with the opener or door components.
- D. Areas of the brick exterior and chimney show evidence of prior tuckpointing repairs. These areas appear to have been recent to address mortar joint deterioration.

Downspout extension does not extend enough from the foundation

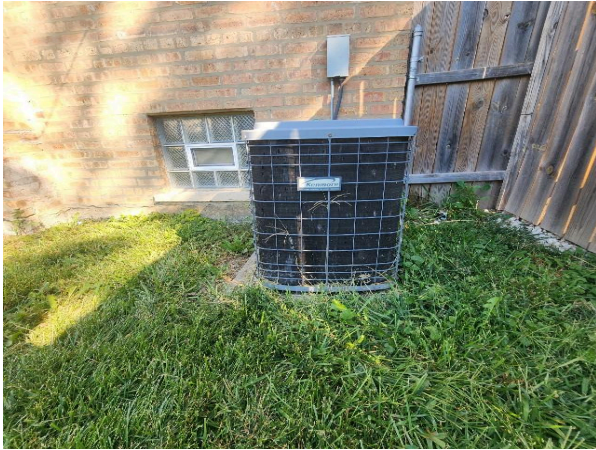
- a. The exterior air conditioning unit has dirty and damaged condenser fins. This condition can reduce cooling efficiency and place additional strain on the system.

Undetermined age Kenmore air conditioner

1. **HVAC:** The undetermined age Kenmore air conditioning system operated. The 2017 Ameristar furnace operated. Professional servicing of the HVAC system should be done prior to closing and on a regular basis going forward. The below issues should be addressed at the time of servicing:

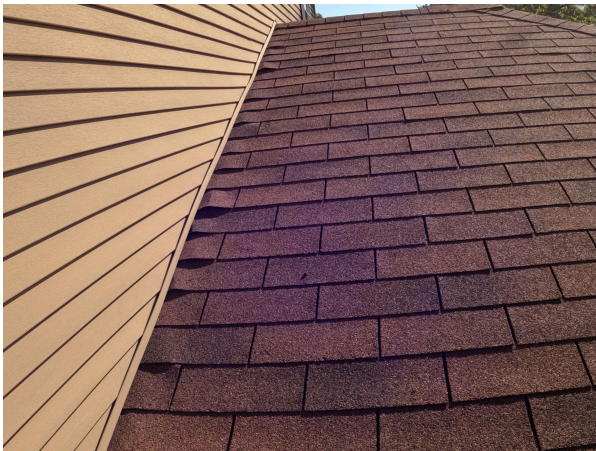
2. **ROOF:** Uplifted asphalt shingles were observed on the rear roof. This condition may allow water intrusion and reduce the effectiveness of the roof covering. Recommend repair by a qualified roofing contractor to prevent potential leaks and extend roof life. **GARAGE:** Tree limbs near the garage roof are touching the roofing surface. This contact can cause damage to shingles, gutters, and roofing over time, and may provide a pathway for pests. Also, a cable wire was observed laying across the garage roof. While terminated, this condition is unsightly and may contribute to roof wear over time.

Uplifted asphalt shingles

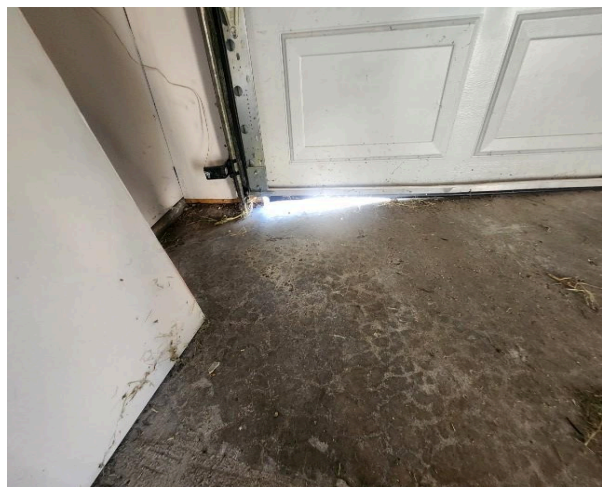
Garage overhead door not flushed with floor

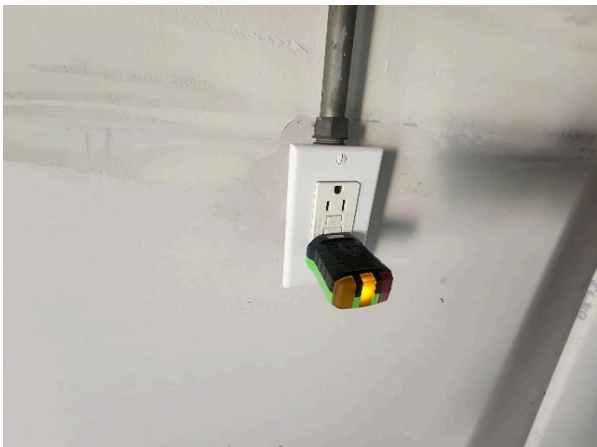
3. **ELECTRIC:**
  - a. The garage contains an ungrounded electrical outlet. Ungrounded outlets do not provide adequate protection for modern appliances or electronics and may present a safety concern.

Garage ungrounded outlet

\*Due to the nature of electricity, all electrical issues large or small should always be addressed by an electrician before closing.

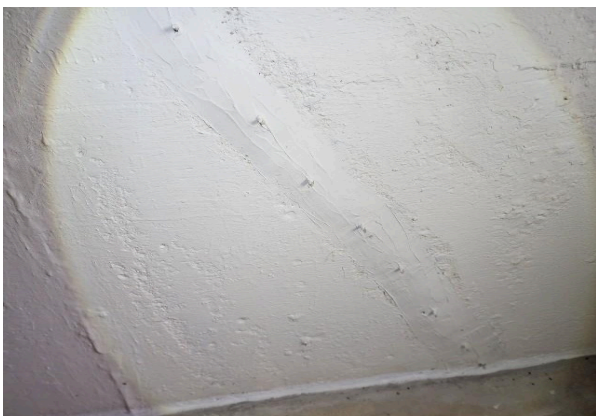
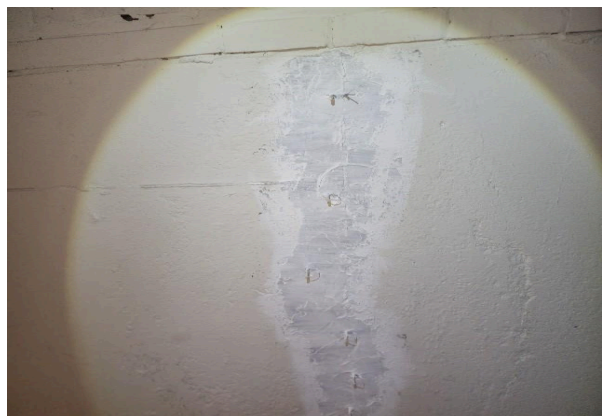
- E. The basement wall has what appear to be previously repaired cracks.
- F. Three windows in the primary bedroom show evidence of broken thermal seals, which may reduce energy efficiency and result in condensation or fogging between panes.
- G. Window screens at the main staircase and dining room are torn, which may reduce insect protection and affect appearance.
- H. The dining room window fails to stay open, which may present an operational and safety concern.
- I. The kitchen window is loose and detaches when operated, which may present a safety hazard and affect proper function.

Previous repaired crack in basement wall

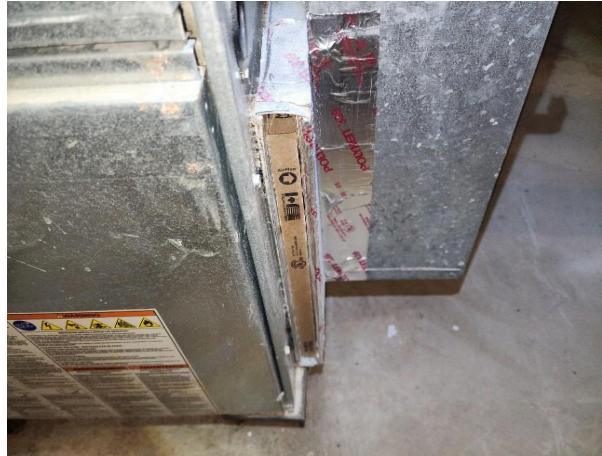
- b. The furnace cabinet contains seasonal dust accumulation. In addition, the air filter is not properly sealed, which may allow unfiltered air and debris to enter the system.

Furnace unsealed filter
