# Home Inspection Report

of  
Address

**INSPECTIONS**™

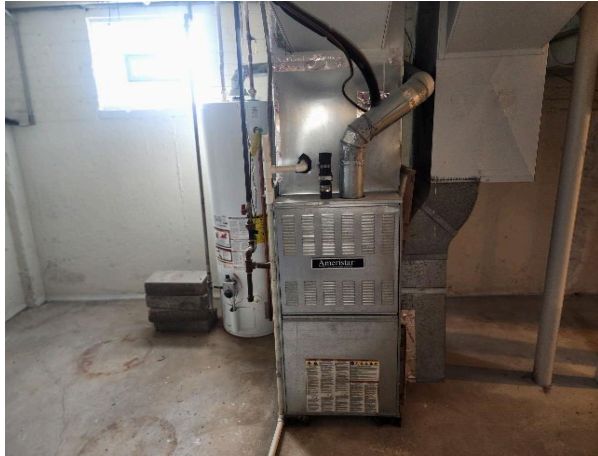
- b. The furnace cabinet contains seasonal dust accumulation. In addition, the air filter is not properly sealed, which may allow unfiltered air and debris to enter the system.

1. **HVAC:** The undetermined age Kenmore air conditioning system operated. The 2017 Ameristar furnace operated. Professional servicing of the HVAC system should be done prior to closing and on a regular basis going forward. The below issues should be addressed at the time of servicing:
